# ENGINE—CYLINDER HEAD DECK LEAK—4.6 AND 5.4L ENGINES—NEW “SERVICE-ONLY” GASKET AND CYLINDER HEAD KITS AVAILABILITY

Article No.  
03-6-2

**FORD:** 1999-2002 CROWN VICTORIA, MUSTANG  
1999-2001 E SERIES, EXPEDITION, F-150, SUPER DUTY F SERIES  
2000-2001 EXCURSION

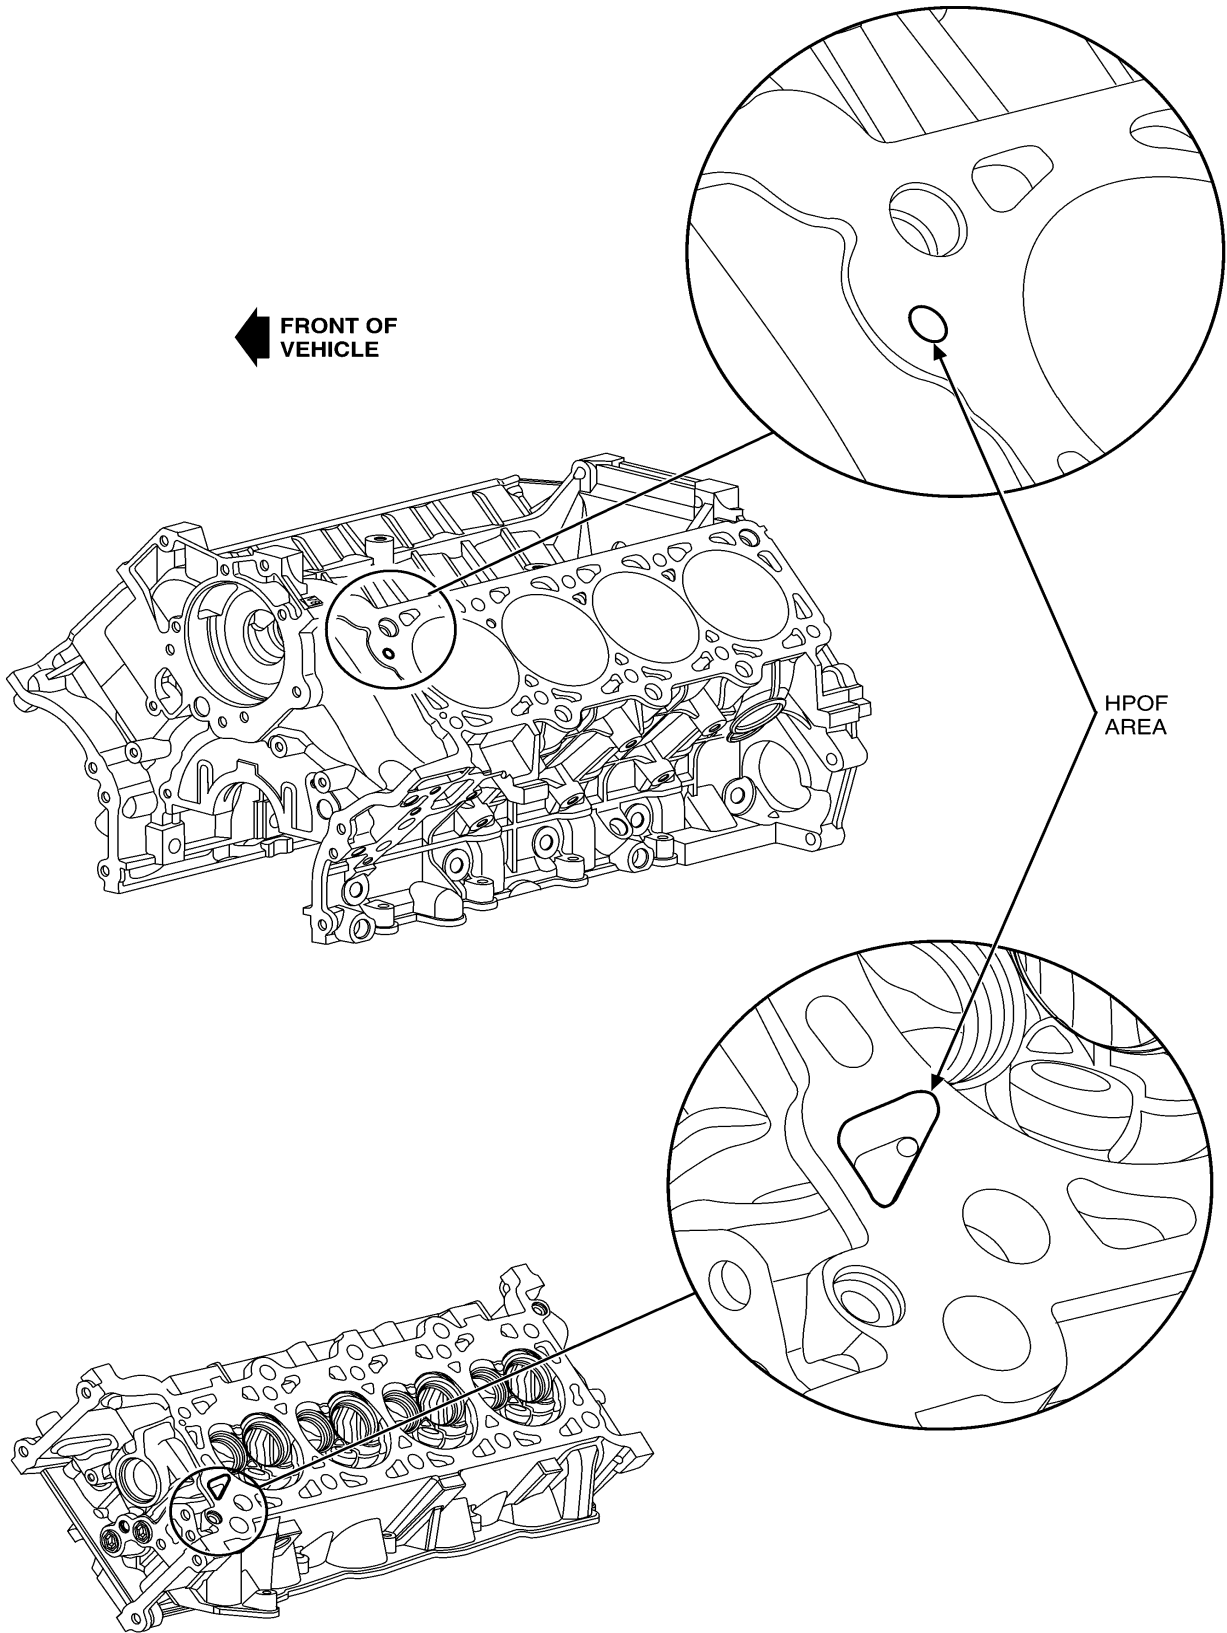
Figure 1 - Article 03-6-2

Cylinder heads damaged by brinnelling (depression marks from original gasket) of the head may still be reusable. The revised “Service-Only” gasket has a feature by which the embossed sealing area does not follow the same sealing path as the original gasket. This area is surrounding the High Pressure Oil Feed (HPOF) area. It is triangular in shape and is found in the rear of the passenger side cylinder head, or, in the front of the drivers side cylinder head (Figure 1 and Figure 2).

DRIVERS SIDE (LEFT BANK)

Once an oil leak is verified with a black light test at the head gasket joint, replacement of the head gasket can be performed. If the head was damaged by chip contamination, the head should be replaced. A revised “Service-Only” gasket is now released for both of these cases.

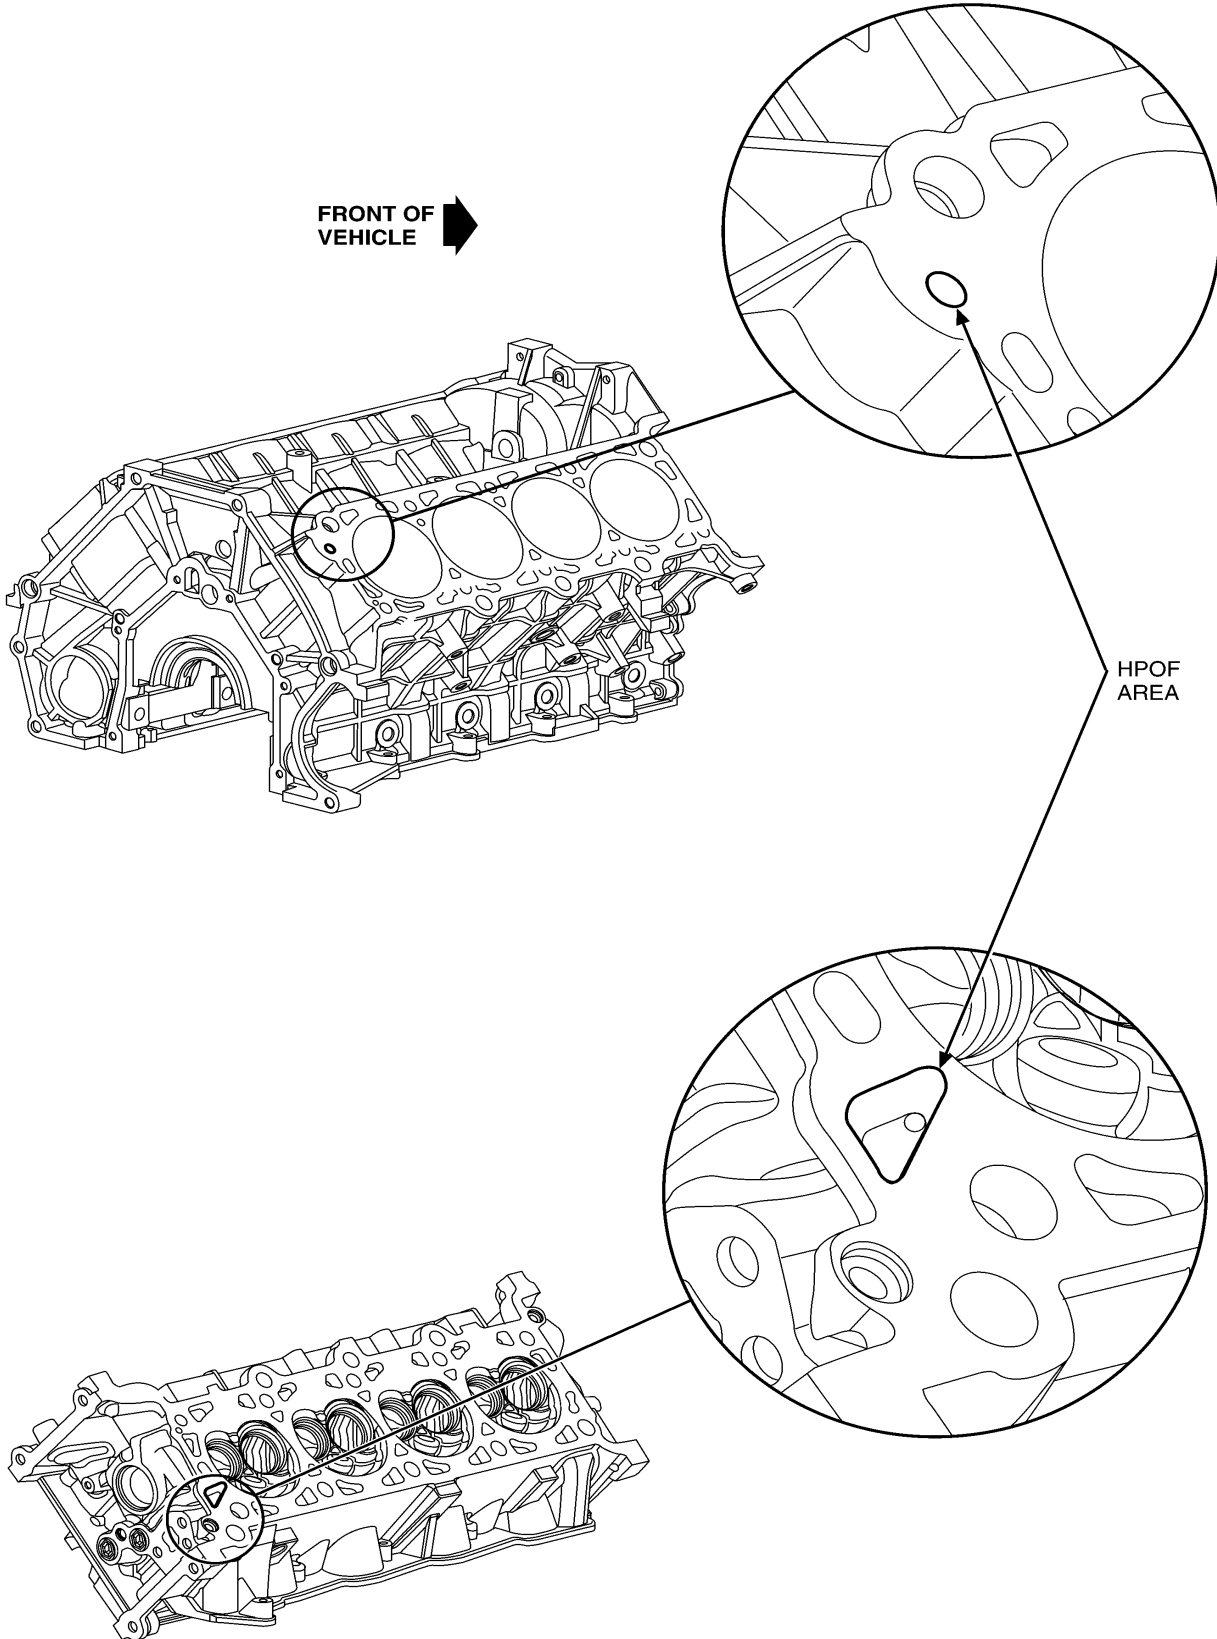
Figure 2 - Article 03-6-2

PASSENGER SIDE (RIGHT BANK)

HPOF  
AREA
