- **COOLING SYSTEM—3.8L—UNDETERMINED LOSS OF COOLANT**
- **COOLING SYSTEM—4.2L—UNDETERMINED LOSS OF COOLANT**
- **ENGINE—3.8L—ENGINE OIL CONTAMINATED WITH COOLANT**
- **ENGINE—4.2L—ENGINE OIL CONTAMINATED WITH COOLANT**

**Article No.
99-20-7**

FORD: 1996-1997 THUNDERBIRD
1996-1998 MUSTANG, WINDSTAR
1997-1998 E-150, E-250, F-150

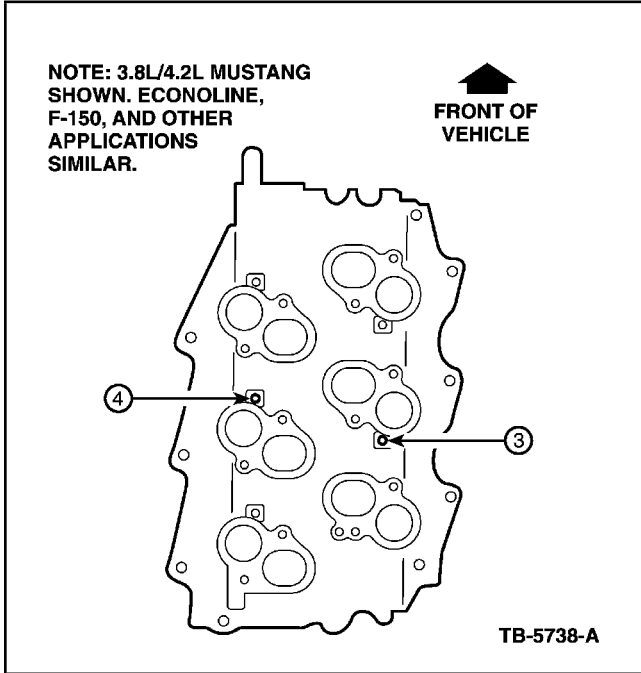
Figure 1 - Article 99-20-7

DUE TO SLIGHTLY THICKER SIDE GASKET BEAD MATERIAL, THE CENTER BOLTS (#3 AND

#4, FIGURE 1) IN THE LOWER INTAKE MANIFOLD MUST FIRST BE INSTALLED (HAND-TIGHTENED) AND FASTENED. DRAWING DOWN THESE BOLTS FIRST, WILL FACILITATE INSTALLATION OF THE OTHER BOLTS.
