FRONT SUSPENSION POPPING NOISE WHILE TURNING RIGHT OR LEFT—VEHICLES BUILT BEFORE 4/8/2005

TSB 05-9-11

FORD:
2005 Mustang

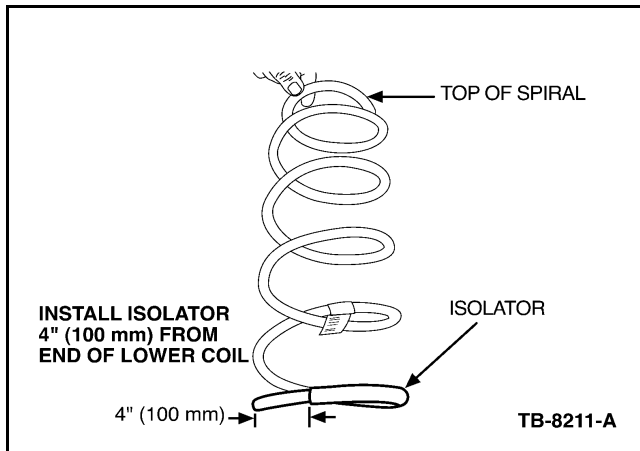
Figure 1 - Article 05-9-11

Some 2005 Mustang vehicles built before 4/8/2005 may exhibit an intermittent popping noise from the front of the vehicle while turning left or right. The noise will typically occur during low speed maneuvers and may occur multiple times while turning.

1. Remove the strut and spring assembly. Refer to Workshop Manual Section 204-01.
2. Disassemble the strut and spring assembly.
3. If the springs do not have a rubber isolator on the bottom spring coil, install isolators. Clean off any dirt prior to installing the isolator. The isolator should be installed 4" (100 mm) from the end of the coil (Figure 1).
