Computers and Control Systems: By Symptom

Engine - Hard Cold Starts/Hesitation/Stalls On Start-Up

91-25-7

- ^ HARD COLD START - DURING INITIAL START-UP, IDLE OR DECEL - EFI ENGINES - SLUDGE IN THROTTLE BODY AND/OR IDLE AIR BY-PASS VALVE
- ^ HESITATION/STALLS - DURING INITIAL START-UP, IDLE OR DECEL - EFI ENGINES - SLUDGE IN THROTTLE BODY AND/OR IDLE AIR BY-PASS VALVE

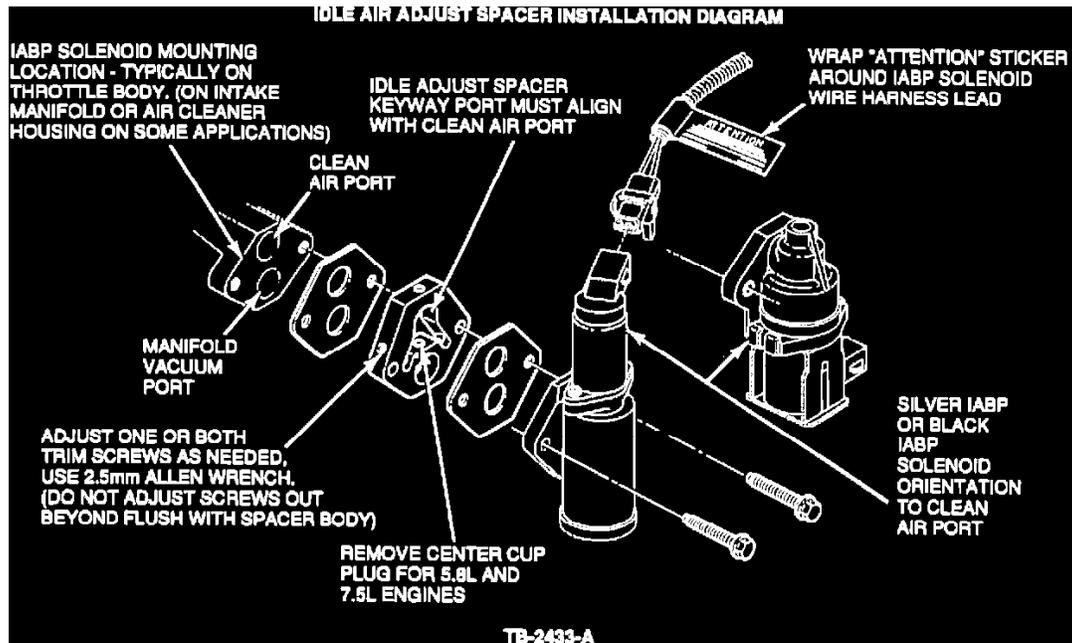
Refer to Figure 2 for a pictorial of the kits components.

Install an idle air by-pass service kit (F2PZ-9F939-A) as applicable to provide a permanent correction for symptoms caused by throttle body sludge deposits. Refer to the instruction sheet included in the kit for installation details. Refer to Figure 1 for a specific application list of EFI (port fuel Injection) engines involved in this TSB article.

The idle air adjust spacer incorporates sludge tolerant design features that eliminate throttle body sludge related conditions. Once installed, throttle body cleaning is not allowed and periodic adjustment of the throttle body is not required.
