# SPARK KNOCK UNDER LIGHT LOAD AND ACCELERATION—3.8L, 3.9L, AND 4.2L—SPLIT PORT INTAKE MANIFOLD RUNNER CONTROL (IMRC)

TSB 07-16-17

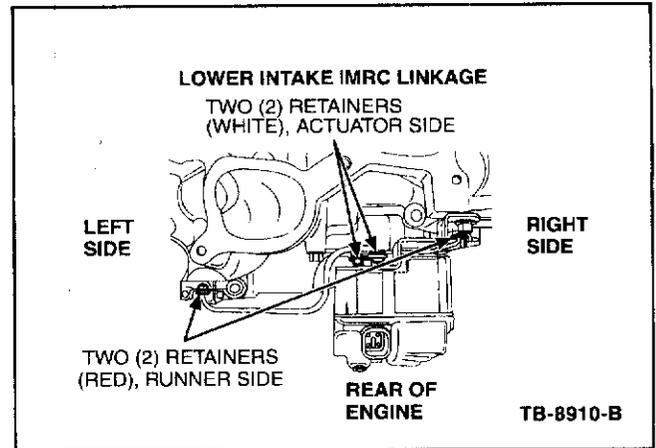
Figure 1 - Article 07-16-17

Various vehicles equipped with a 3.8L, 3.9L or 4.2L engine and Split Port IMRC may exhibit spark knock under light load and acceleration.

Inspect for disconnected IMRC actuator rods.

1. Check both right hand and left hand side IMRC rods are properly attached to the actuator motor and intake manifold runner.
2. If the IMRC actuator rods are found to be connected properly, do not continue with this TSB. Refer to Powertrain Control/Emission Diagnosis Manual.
3. If any IMRC actuator rods are disconnected, refer to Workshop Manual (WSM), Section 303-14 for IMRC service.
4. If any IMRC actuator rod linkages are found disconnected, replace all four (4) linkage rod retainers. (Figure1)

PART NUMBER	PART NAME
F5RZ-9F955-AB	Retainer - Actuator Side (2 Required - White Color)
6F2Z-9F955-A	Retainer - Runner Side (2 Required - Red Color)
